**Flood Control Project Maintenance
Levee Inspections**

Maintenance Issue Types Only, Levee Inspection Report By Mile - Fall 2019

Reclamation District No. 2089 Stark

Waterway	Bank	Unit Miles	Inspection Start/End	Inspector
Unit No. 01 Old River	Right	1.51	11/20/2019 11/20/2019	Alberto De Leon

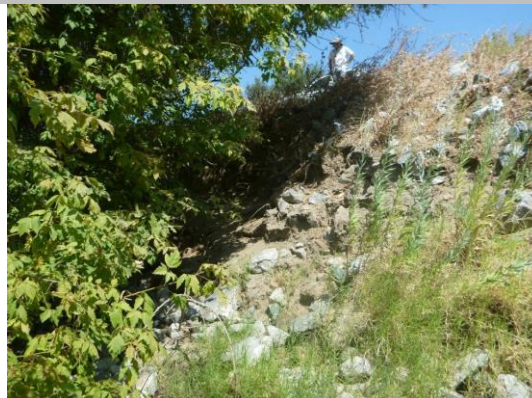
Photo 3 of 3 : LEVAL_FA_2019_508_4325.jpg

LM Start	0.39	Rating **	A/W	Issue No.	50 (cont)
LM End	0.41	Issue Type +	Ma	Location *	WS
Category	Supplemental			GPS Latitude/Longitude	
				Start	End
Item	2017 Storm Damage			37.810150 °	37.810270 °
				-121.412930 °	-121.413240 °
DWR ID	LMA-414				
Comment Code					
Inspector Comment					
Levee Evaluation Comments					
Description:Slope protection repairs are needed along the waterside slope due to erosion and riprap displacement from high water. Based upon levee inspections, it was determined the waterside levee slope is eroding, deteriorating, and degrading. The eroded levee sections need to be restored back to design standards to prevent further deterioration and damage.					
Site ID No:508					
Site Designation:LMA-414					
Repair Type: Erosion					
Rating:Serious					
Field Date:8/16/2017					
Notes: Large erosion around tree with a 12' vertical cut.

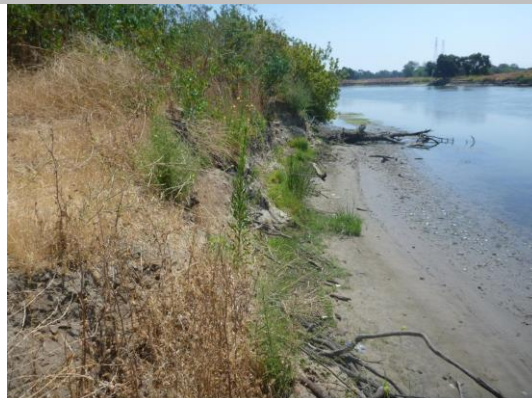
Photo 1 of 3 : LEVAL_FA_2019_507_4335.jpg

LM Start	0.60	Rating **	A/W	Issue No.	56
LM End	0.61	Issue Type +	Ma	Location *	WS
Category	Supplemental			GPS Latitude/Longitude	
				Start	End
Item	2017 Storm Damage			37.812000 °	37.812100 °
				-121.415700 °	-121.415900 °
DWR ID	LMA-413				
Comment Code					
Inspector Comment					
Levee Evaluation Comments					
Description:Slope protection repairs are needed along the waterside slope due to erosion and riprap displacement from high water. Based upon levee inspections, it was determined the waterside levee slope is eroding, deteriorating, and degrading. The eroded levee sections need to be restored back to design standards to prevent further deterioration and damage.					
Site ID No:507					
Site Designation:LMA-413					
Repair Type: Erosion					
Rating:Serious					
Field Date:8/16/2017					
Notes: Vertical cut on outside bend of river

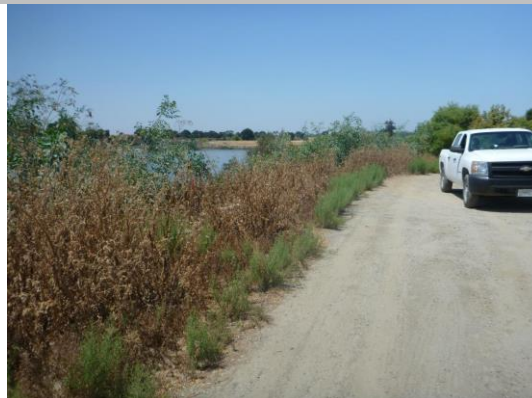
Photo 3 of 3 : LEVAL_FA_2019_507_4340.jpg

LM Start	0.60	Rating **	A/W	Issue No.	56 (cont)
LM End	0.61	Issue Type +	Ma	Location *	WS
Category	Supplemental			GPS Latitude/Longitude	
				Start	End
Item	2017 Storm Damage			37.812000 °	37.812100 °
				-121.415700 °	-121.415900 °
DWR ID	LMA-413				
Comment Code					
Inspector Comment					
Levee Evaluation Comments					
Description:Slope protection repairs are needed along the waterside slope due to erosion and riprap displacement from high water. Based upon levee inspections, it was determined the waterside levee slope is eroding, deteriorating, and degrading. The eroded levee sections need to be restored back to design standards to prevent further deterioration and damage.					
Site ID No:507					
Site Designation:LMA-413					
Repair Type: Erosion					
Rating:Serious					
Field Date:8/16/2017					
Notes: Vertical cut on outside bend of river
